Coastal dynamics of the eastern Gulf of Finland: toward a quantitative assessment

Alexander Sergeev, Daria Ryabchuk, Vladimir Zhamoida,
Olga Kovaleva, Kaarel Orviku

Coastal erosion processes in the eastern Gulf of Finland and their links with geological and hydrometeorological factors

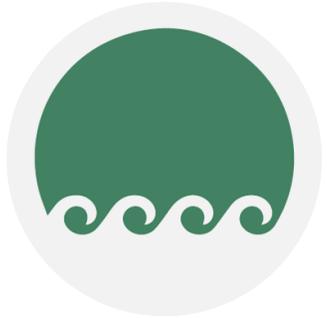
western storms

Most severe erosion events observed in case of coincidence

Based on the results of statistics analyses of coastal monitoring and hydrometeorological data during 2004–2010, it was demonstrated that the most extreme erosional events occur within study area when three unfavourable conditions take place simultaneously: 1) long-lasting west or south-west storms; 2) high water level, and 3) the absence of stable sea ice (Ryabchuk et al. 2011). The results of coastal monitoring for 2011–2017 support this hypothesis.

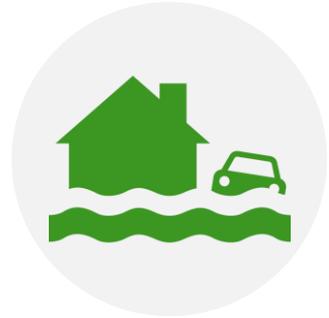
**storm surge
(higher 2 m)**

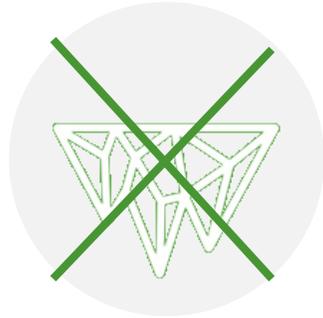
absence of sea ice

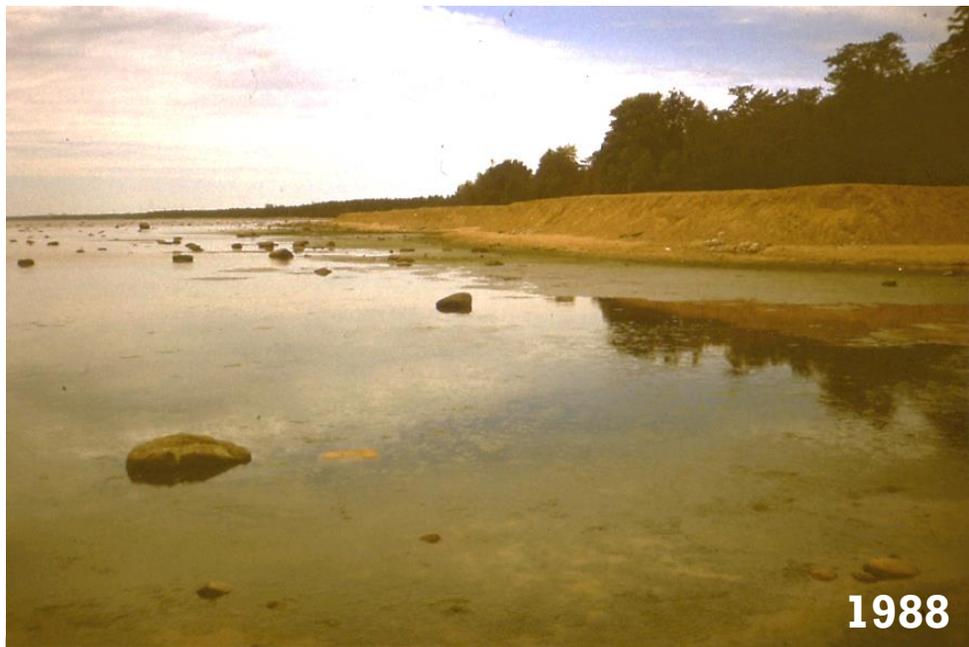
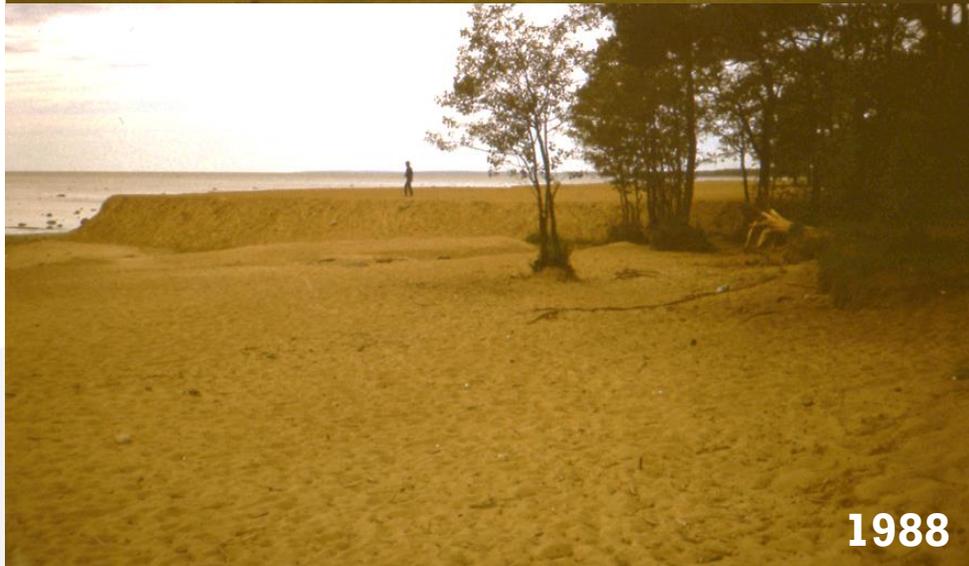
Artificial beach in Komarovo village, 1988
(courtesy by prof.Kaarel Orviku)

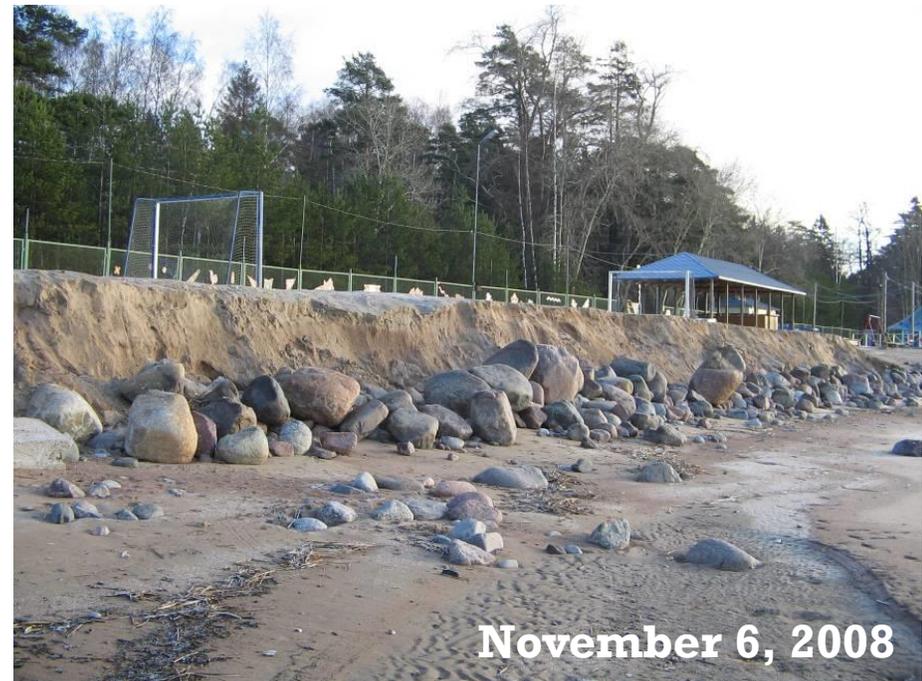
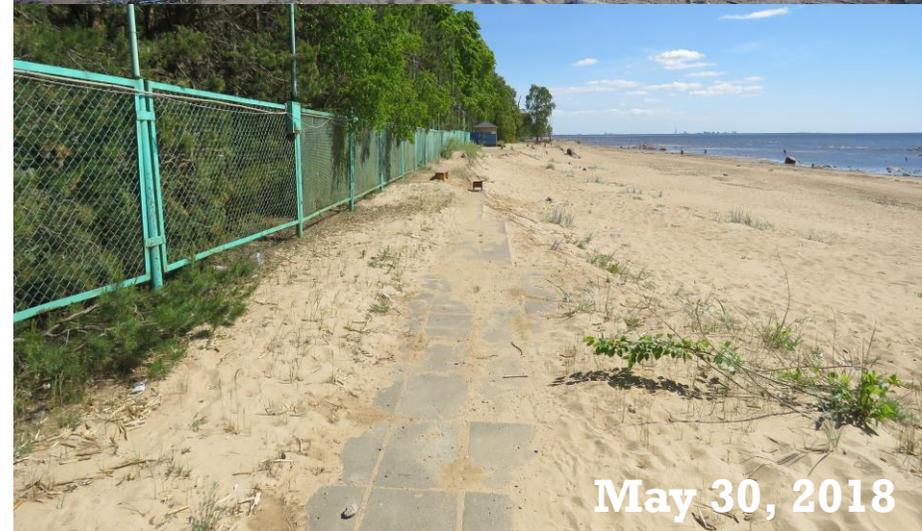
Current situation on the beach

Dynamics of beach erosion by Levelling

In 1988, the beach-face escarpment moved **17.5 m** seaward

The average annual rate of retreat of the terrace scarp was **0.86 m/year**

The maximum rate of shore erosion was recorded in the 2011–2012 storm season and reached **6.5 m/year**

Dynamics of beach erosion in the area of artificial beach backfilling performed in 1988 in Komarovo village. Levelling profiles from 1987 to 1995 according to K. Orviku data, from 2011 according to VSEGEI data.

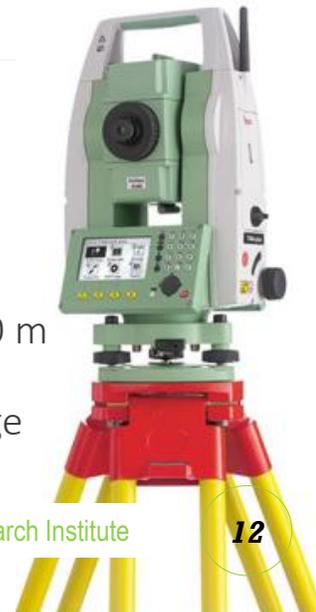
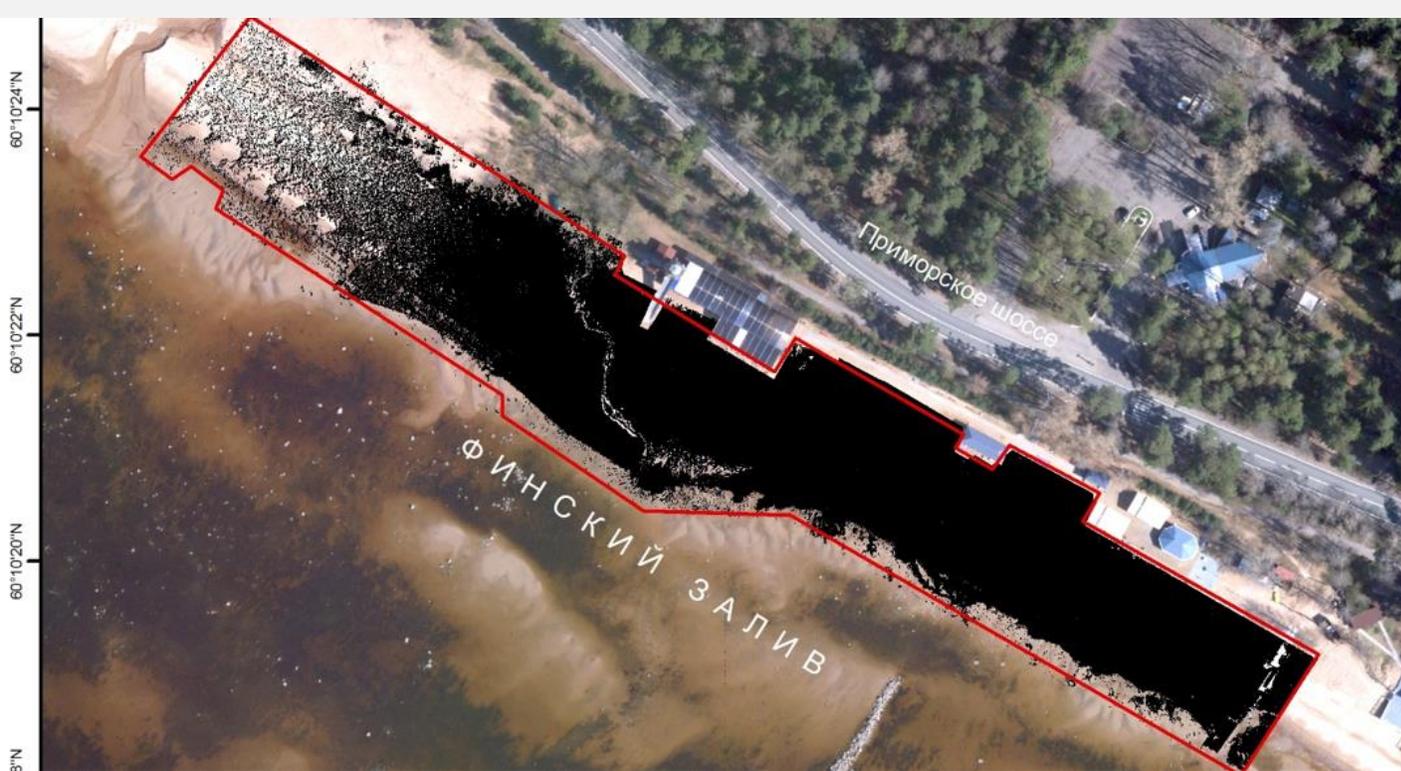
The thickness of the deformation layer of the beach and foredune surfaces in Komarovo village from 2012 to 2017 according to the TLS. 2012–2017 (A). 2016–2017 (B). 2015–2016 (C). 2014–2015 (D). 2013–2014 (E). 2012–2013 (F).

Volumes of sand material displaced in the beach zone of Komarovo village
according to TLS data from 2012 to 2017
(a shore segment (91 m longshore length, 2800 m²))

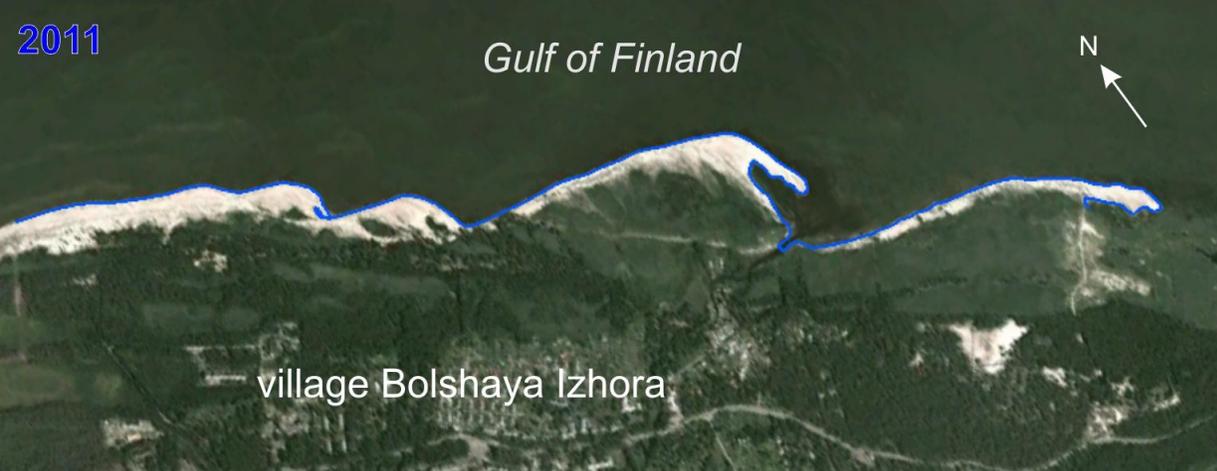
The main features of coastal dynamics of the Bolshaya Izhora 2011 - 2017

- 1 - zone of movement of the longshore sand wave;
- 2 - coastal erosion zone;
- 3 - coastal accumulation zone;
- 4 - position of leveling profiles.

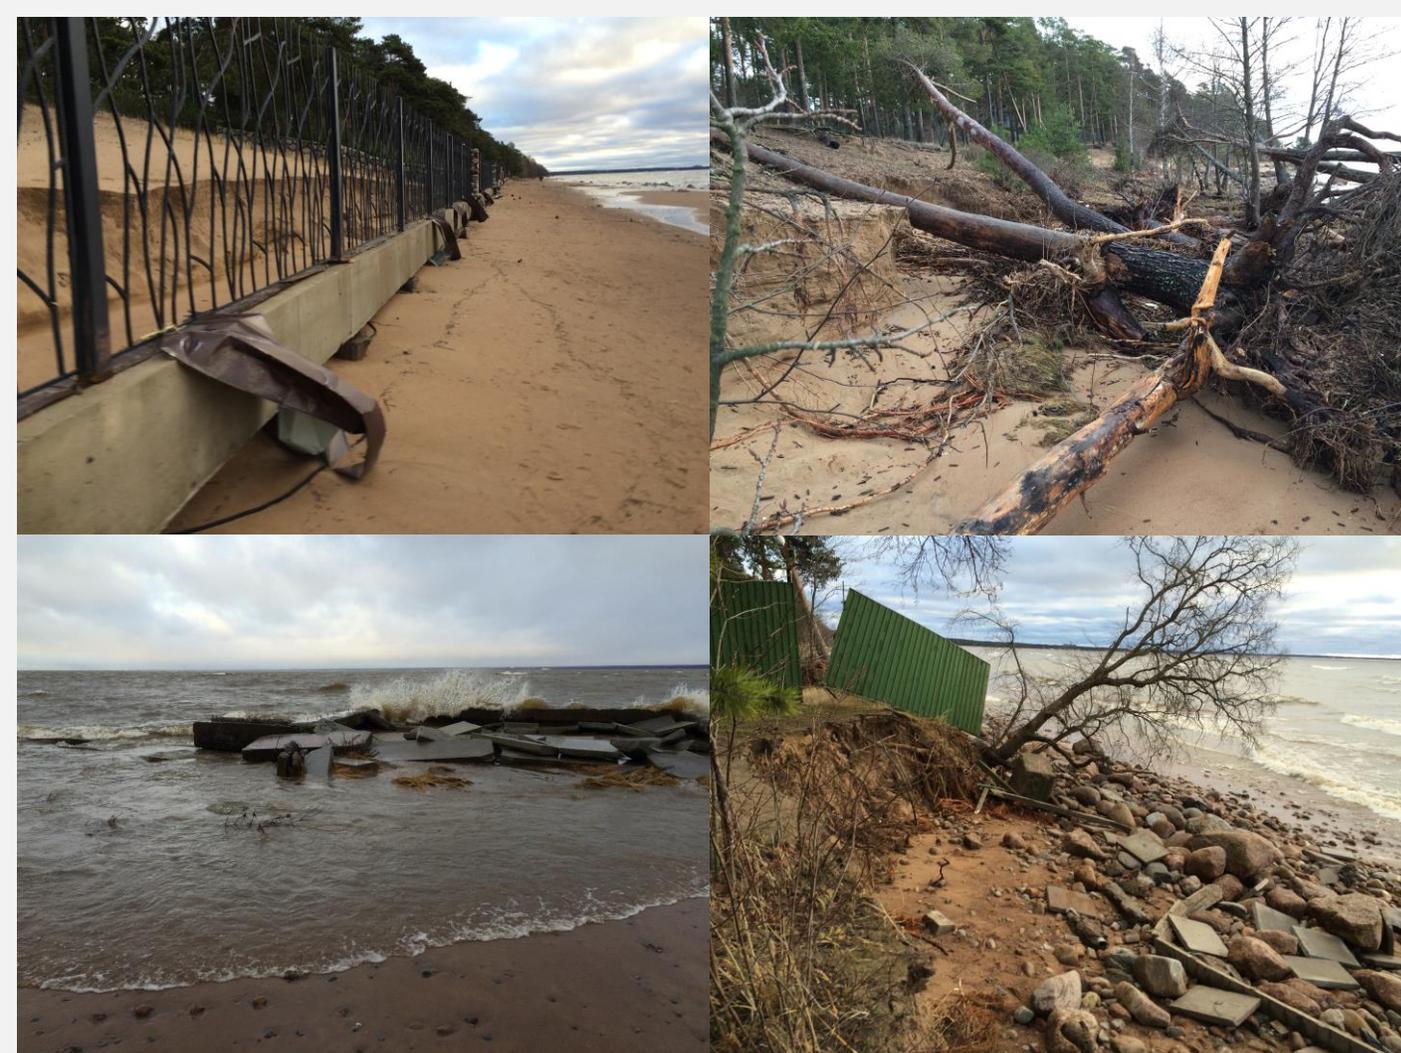
Examples of storm damage in Kurortny District after storm events of December 2015
